ST. CATHERINE'S CHURCH

Thomas Street, Dublin 2

CONSERVATION AND MANAGEMENT PLAN

December 2016

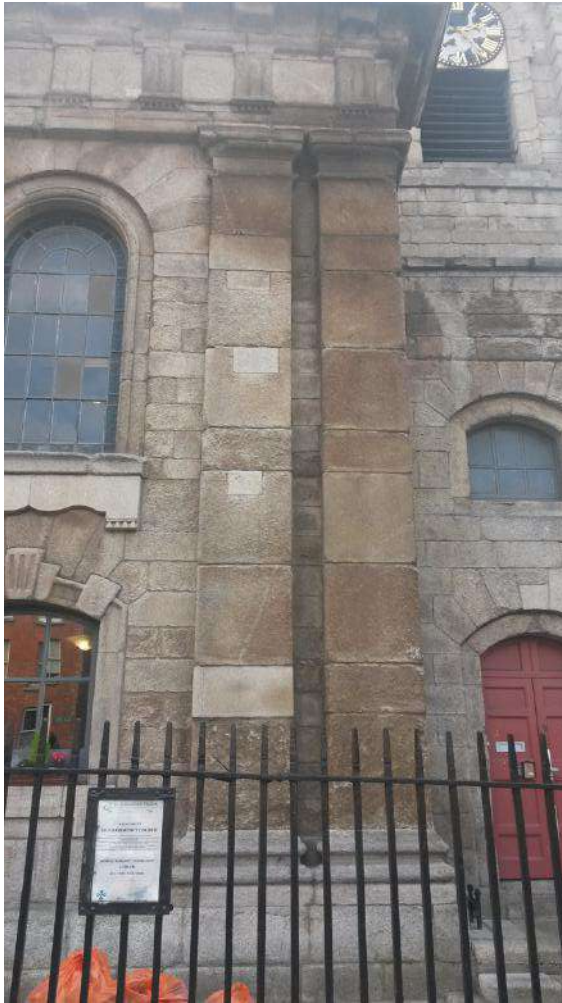
**Granite (front façade):** Of most concern, is the severity of the stone decay evident on the entire north façade. Granular disintegration of the granite and severe discolouration is apparent. The stone has been cleaned on several occasions in the past twelve years with a power washer and a hydrochloric acid cleaner, Neolith.

PLATE 7 Severe discolouration to to top RHS façade on Bay 5, North elevation

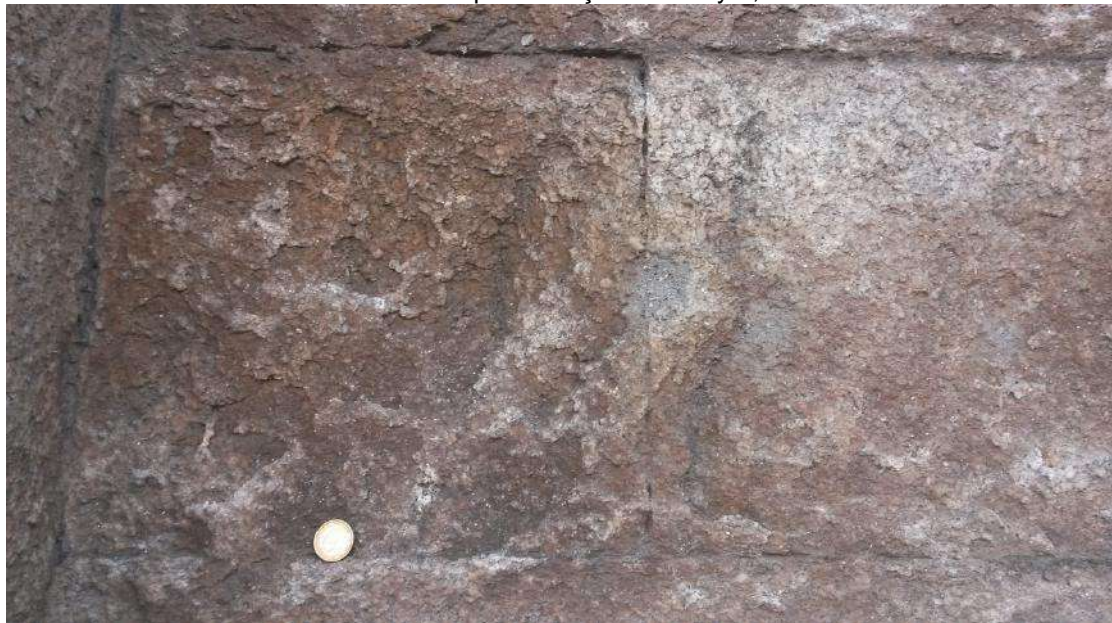
PLATE 8 Detail of Stone Decay on Granite Stone, north facade

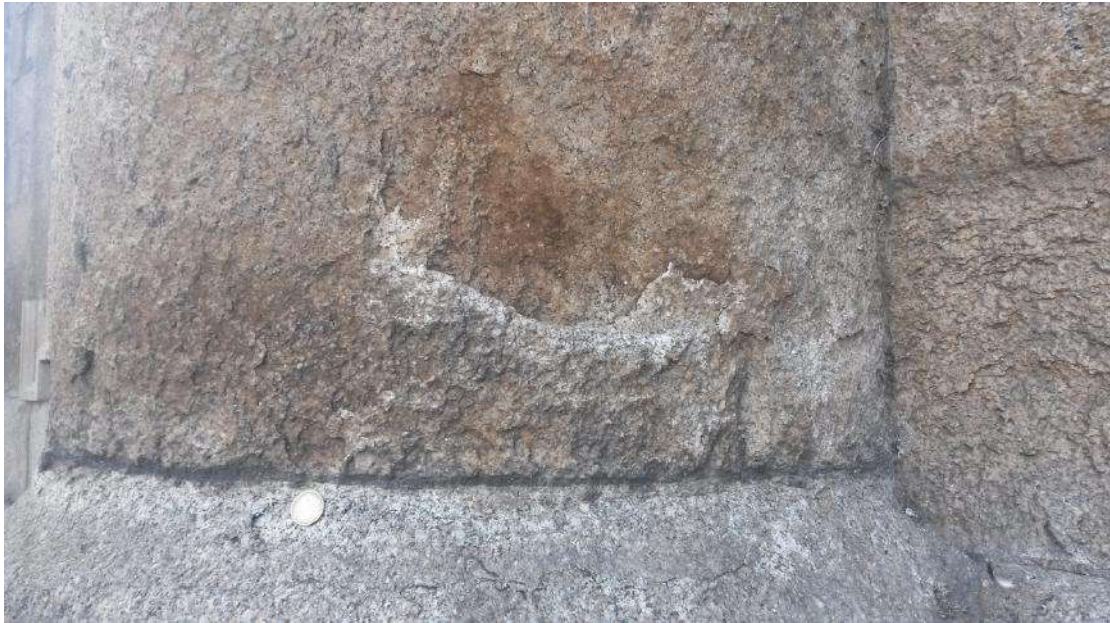
PLATE 9 Detail of Stone Decay on Granite Stone, north façade

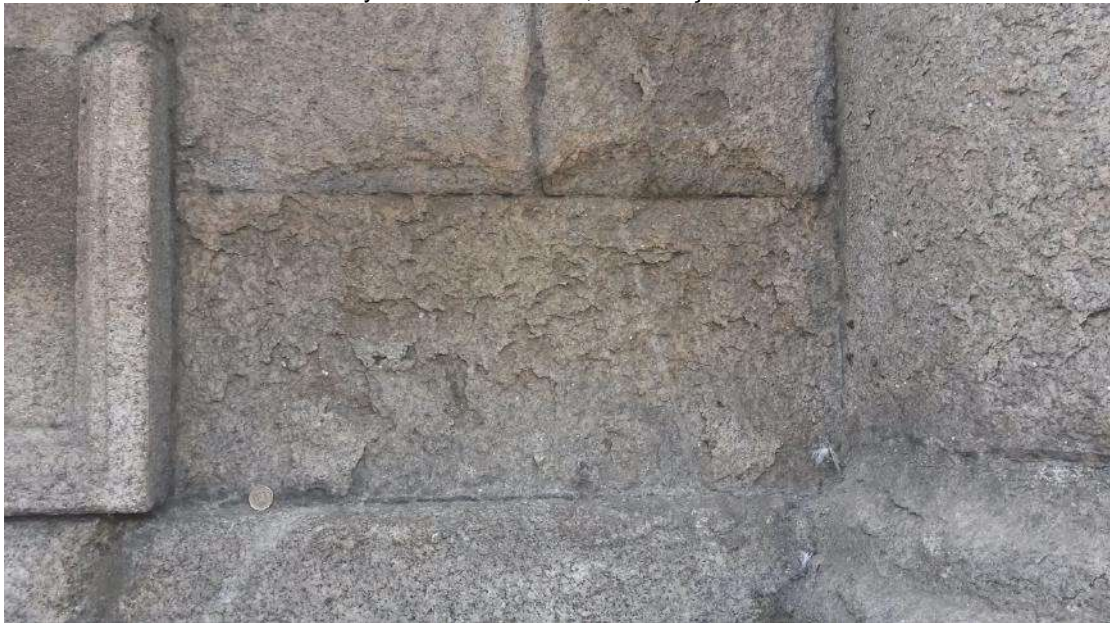
PLATE 10 Detail of Stone Decay on Granite Stone, north façade

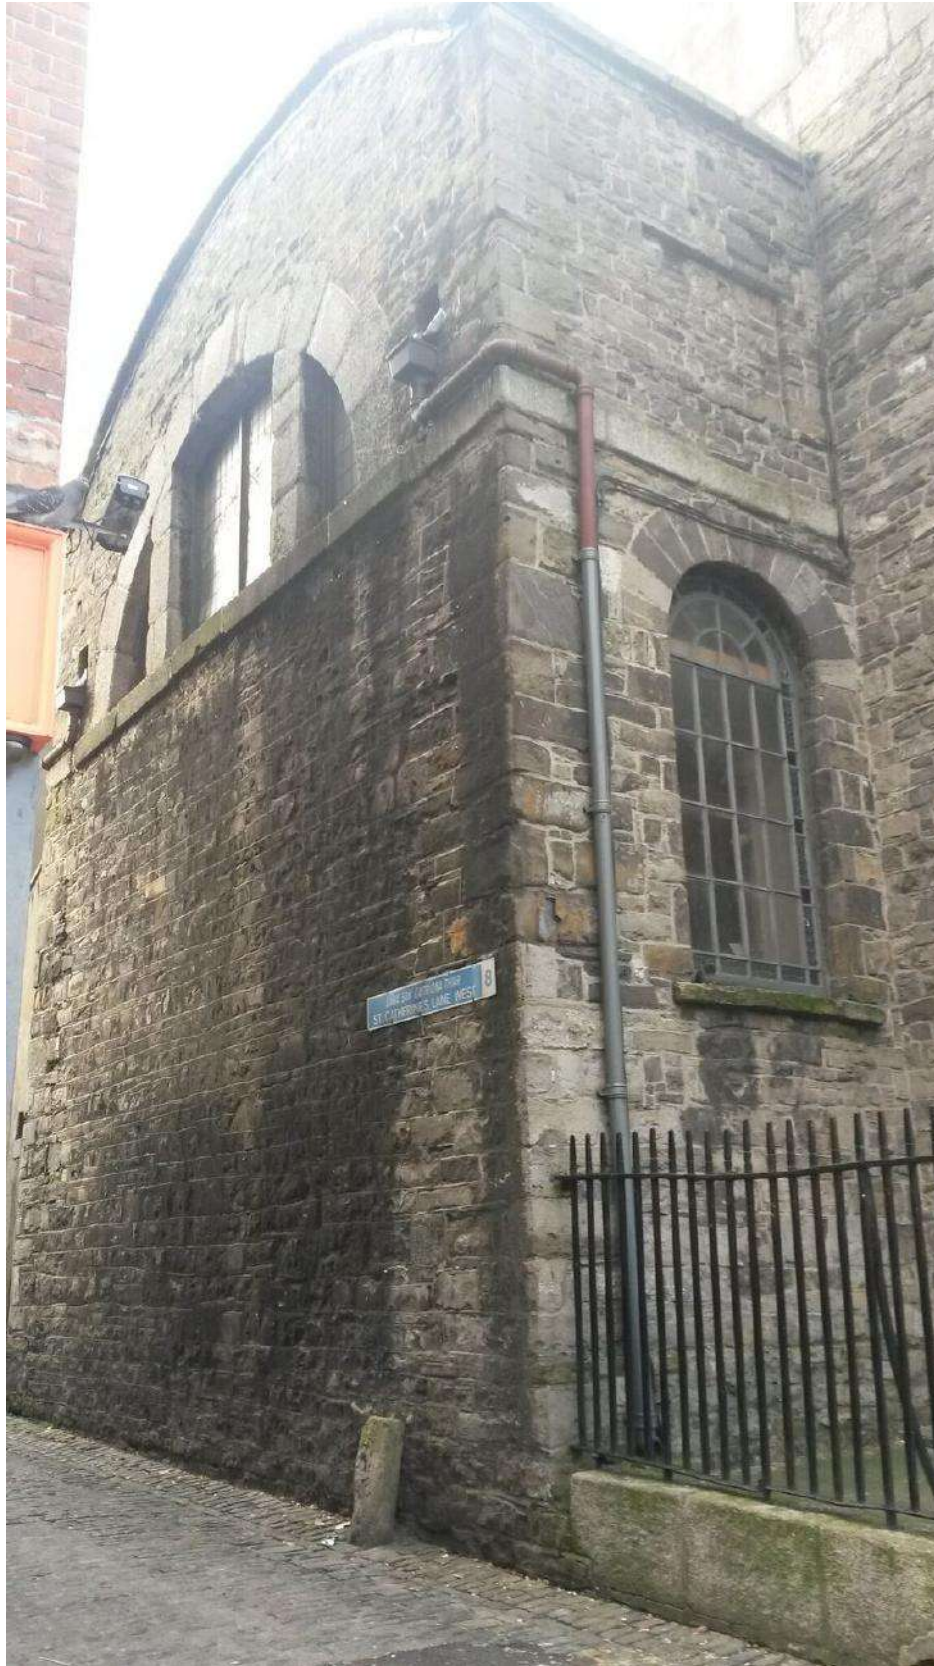
PLATE 18 East Elevation (Note heavy soiling)

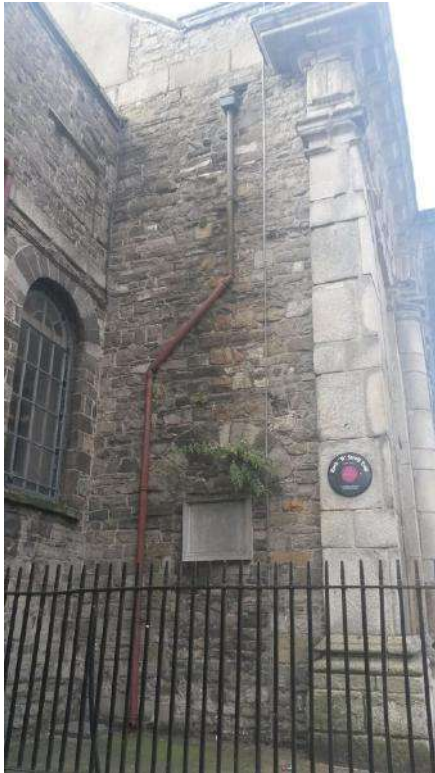
PLATE 19 East façade – Note staining from RWP and vegetation to be remove

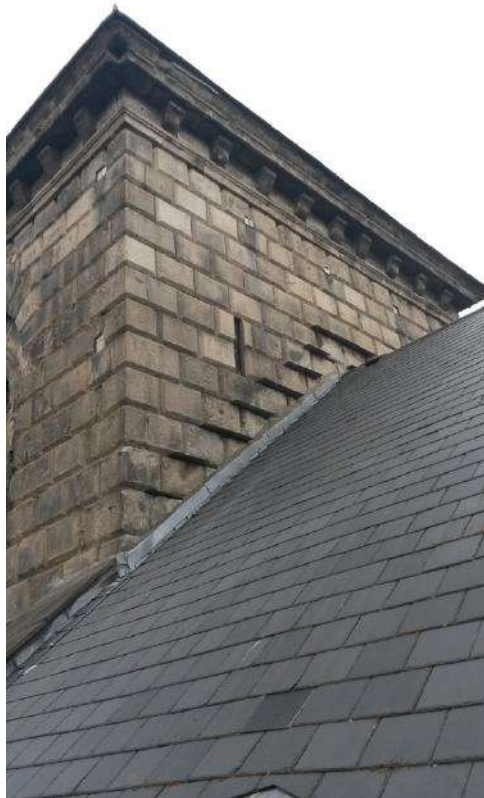
PLATE 22 Projecting slate weatering detail resulting in damage to stone

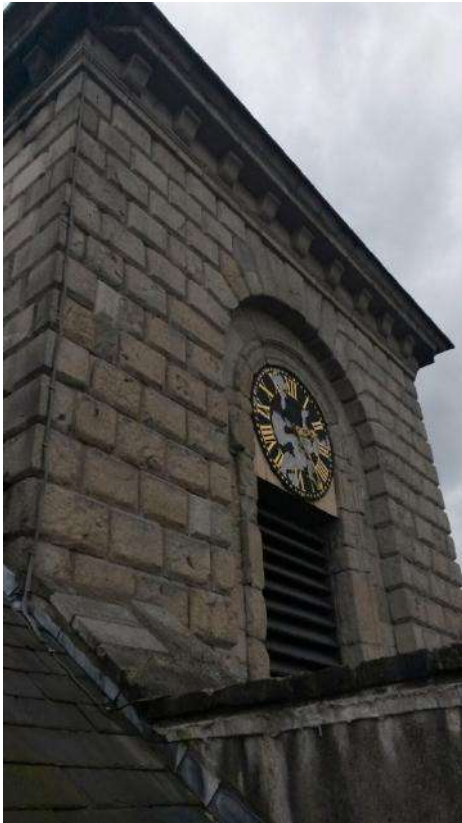
PLATE 23 Belltower, north façade. Clock face on plywood in need of refurbishment,

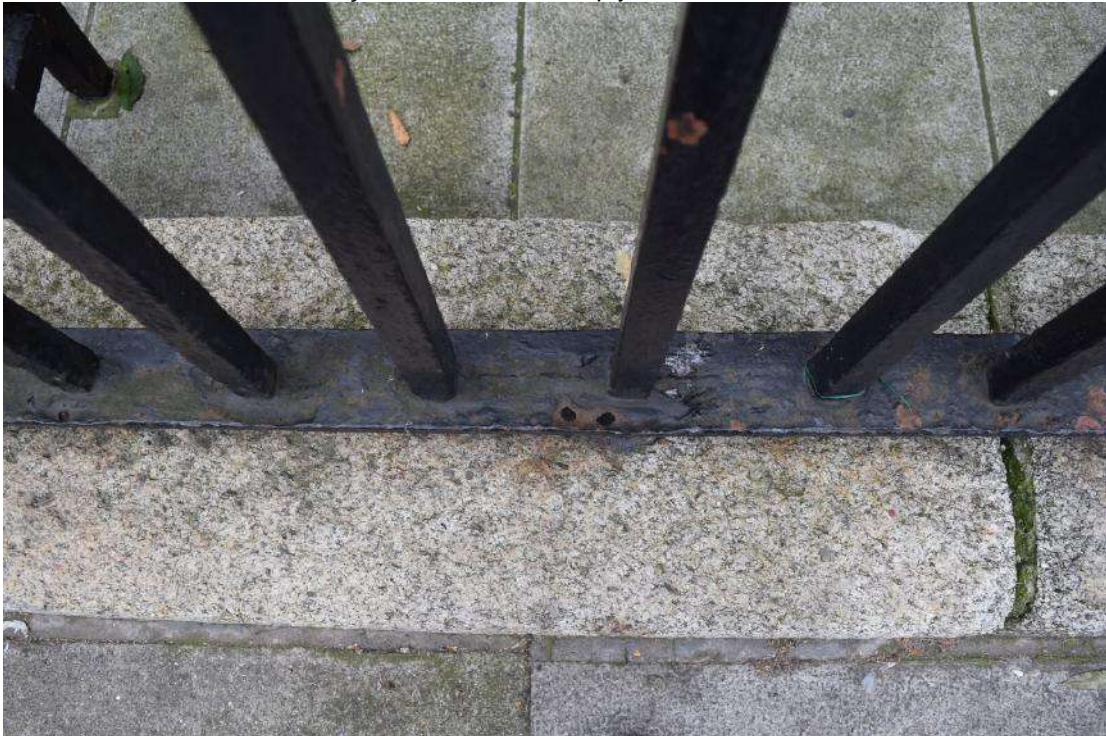
PLATE 24 Coorosion on horizontal bottom rail of iron railings

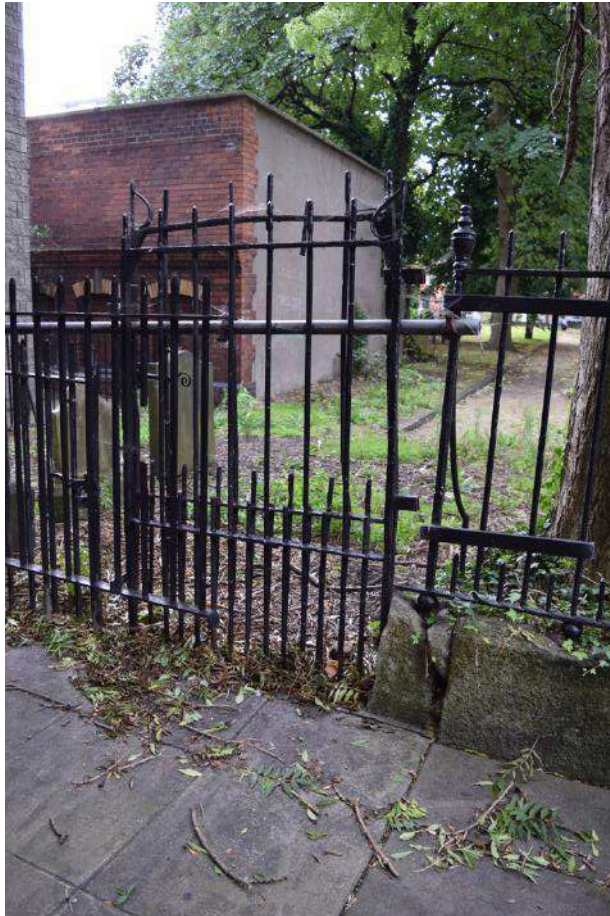
There are a number of mature trees within the adjoining St Catherine's park, one of which is located in very close proximity to the Church. This tree is causing structural damage to the original granite plinth and cast iron railings. It has caused the paving in the yard to become displaced and in need of attention. The overhanging foliage on this tree is also resulting in blocking the parapet gutters on the southern side of the main church roof. It is recommended that the tree be removed to prevent further damage.

PLATE 25 Original gate and railings to southern boundary with tree damage to plinth

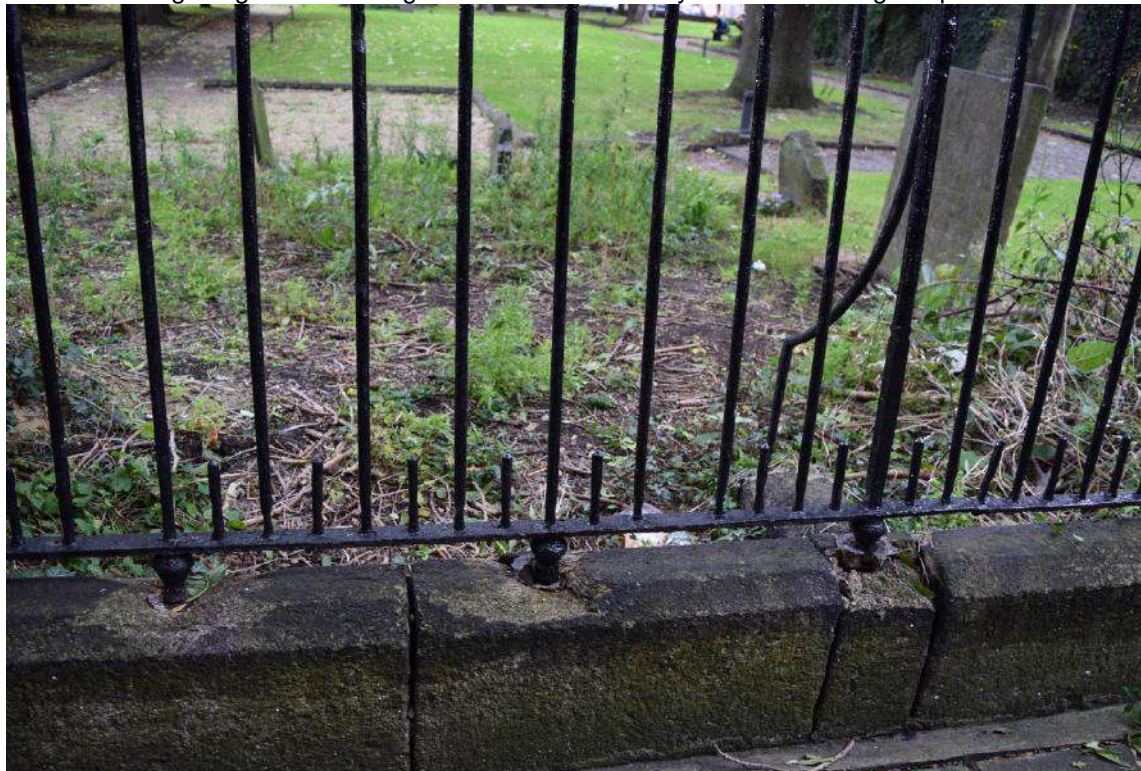
PLATE 26 Southern boundary; expansion of iron filing points have broken granite plinth

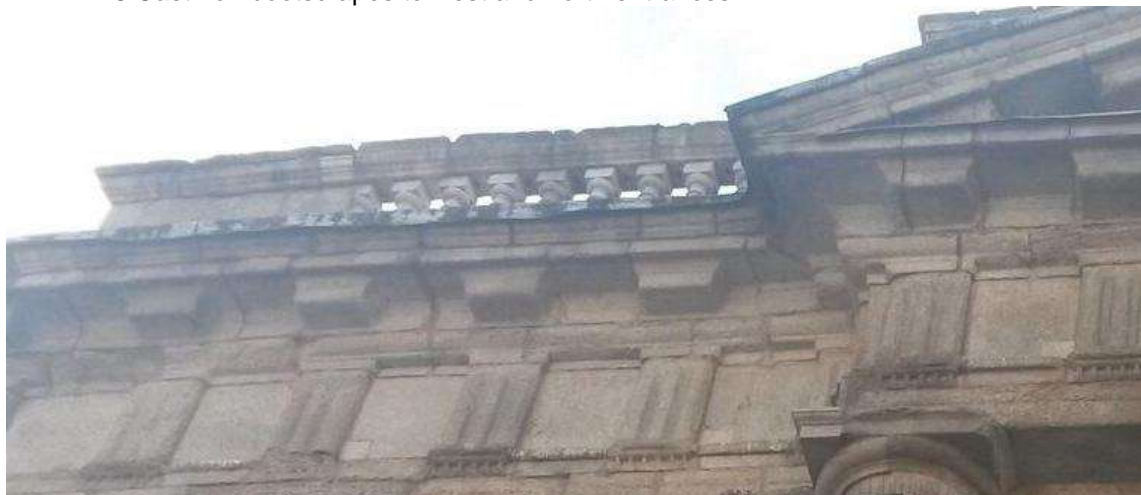
- Secure top rail of balustrade either side of pediment. The granite top rail would have originally been secured to the turned balusters with iron dowels. The top rail was mortar fixed only to replacement concrete balusters, probably installed during the refurbishment works in 1998. This mortar pointing has since cracked and dislodged leaving the individual top rail stones unstable and creating a risk to public safety.

PLATE 29 Coping stones to Northern balustrate unsecure

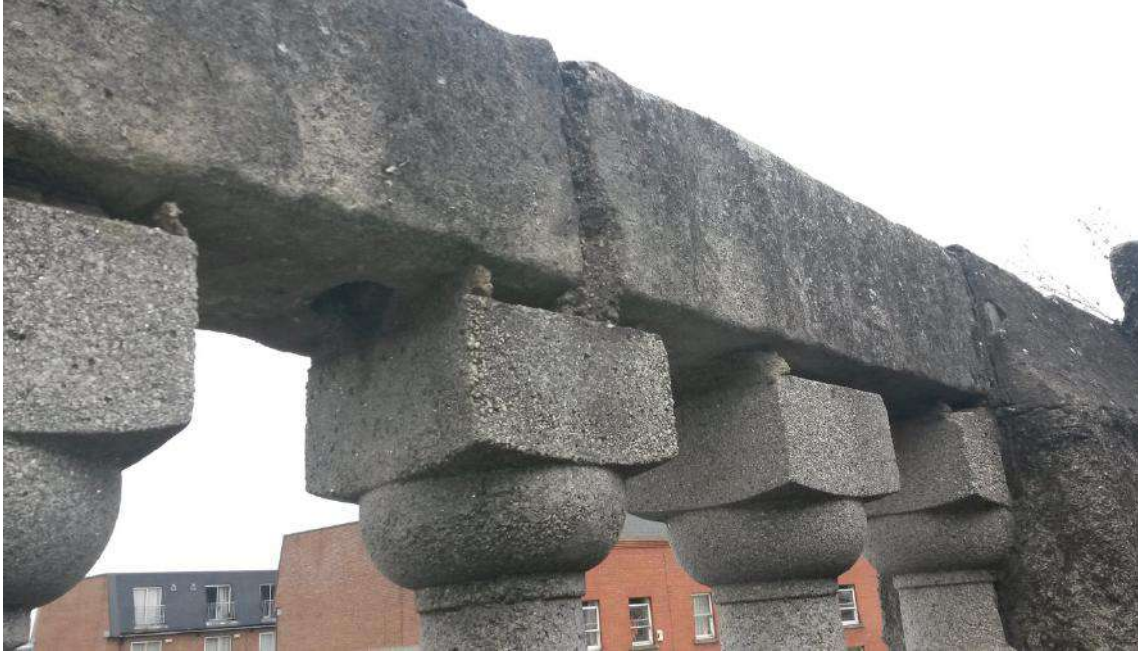
PLATE 30 Mortar fixings for top rail broken away

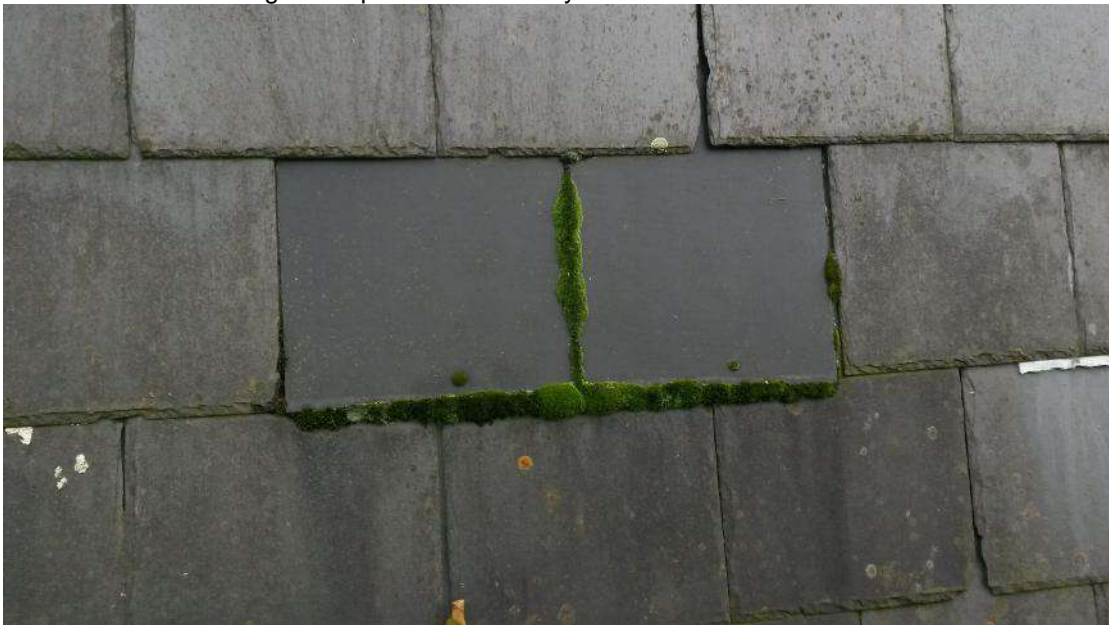
PLATE 31 Remove Moss around roof repair (south facing roof) and inspect for water ingress

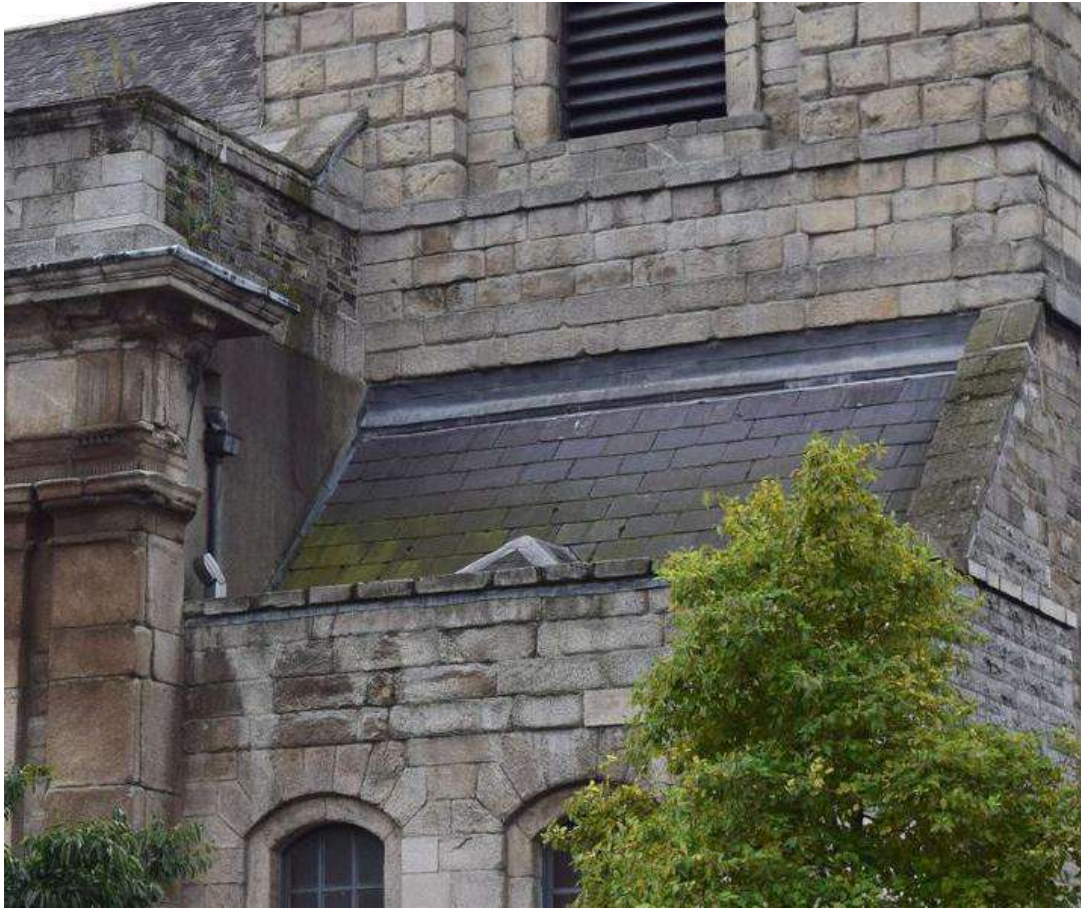
PLATE 32 Moss to be removed from lower roof and gutter checked for leaks/ blockages

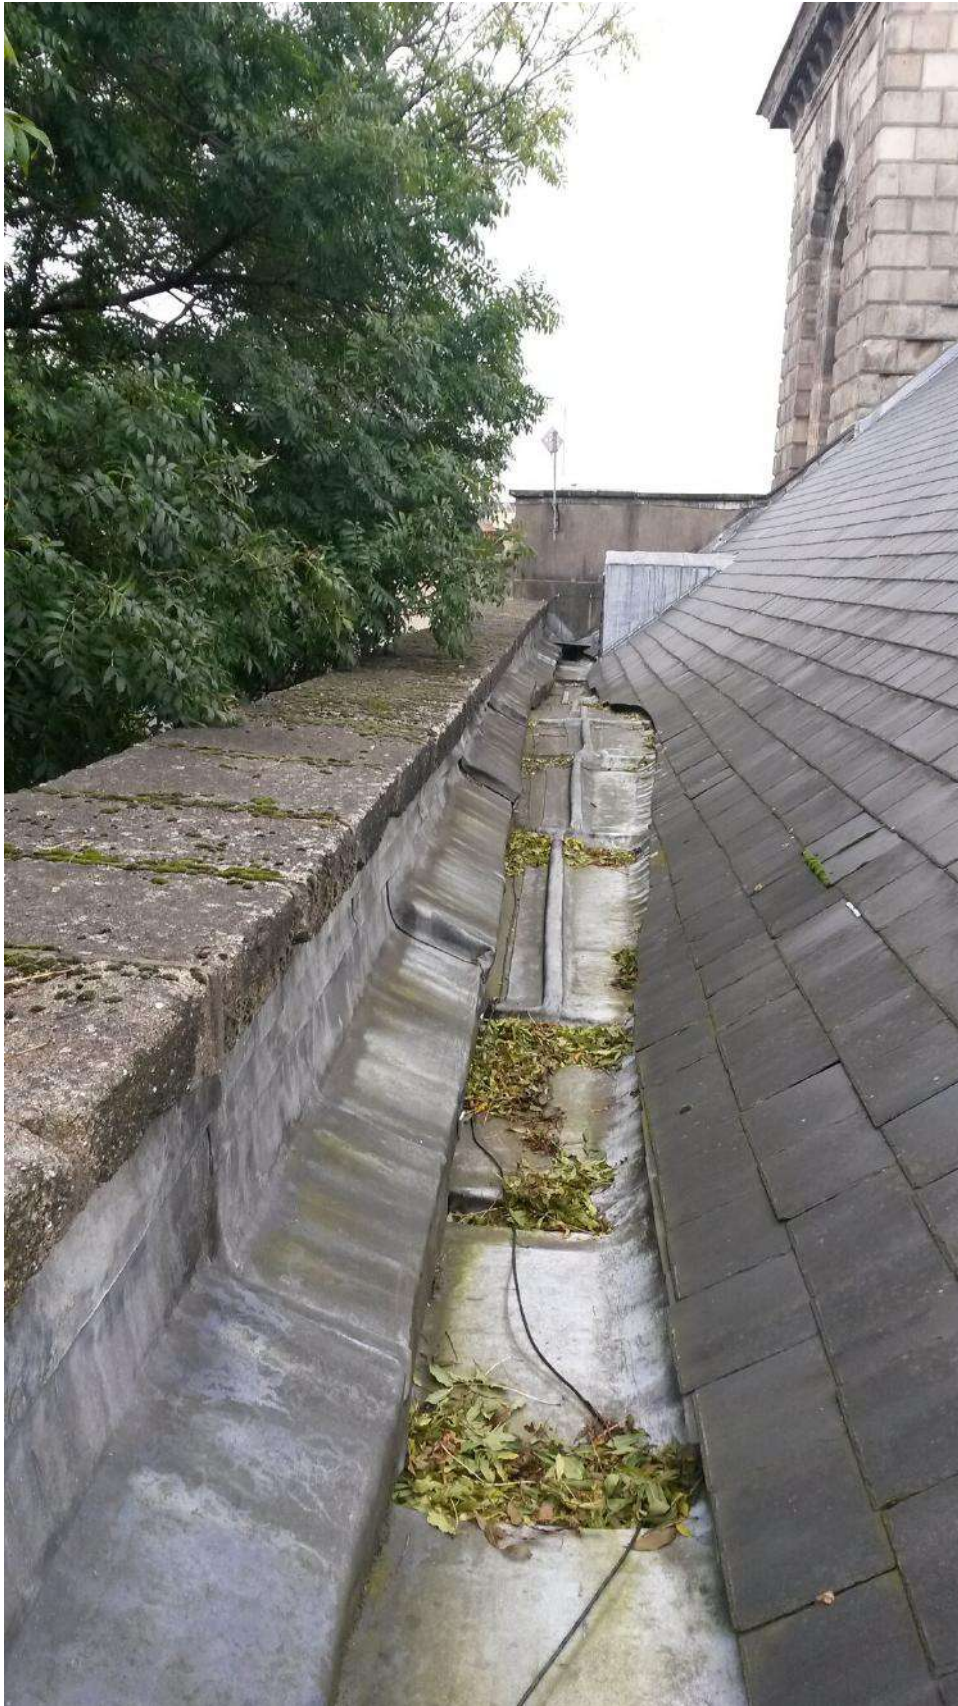
PLATE 33 Overhanging foliage contributing to blocked gutters

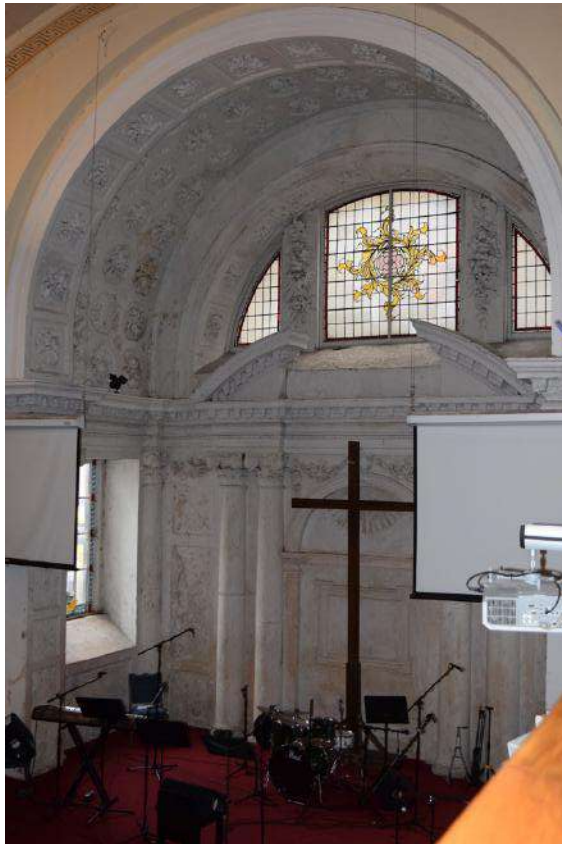
PLATE 35 Chancel – Note cracking to LHS detailed in Fahu Fitzpatrick structural report

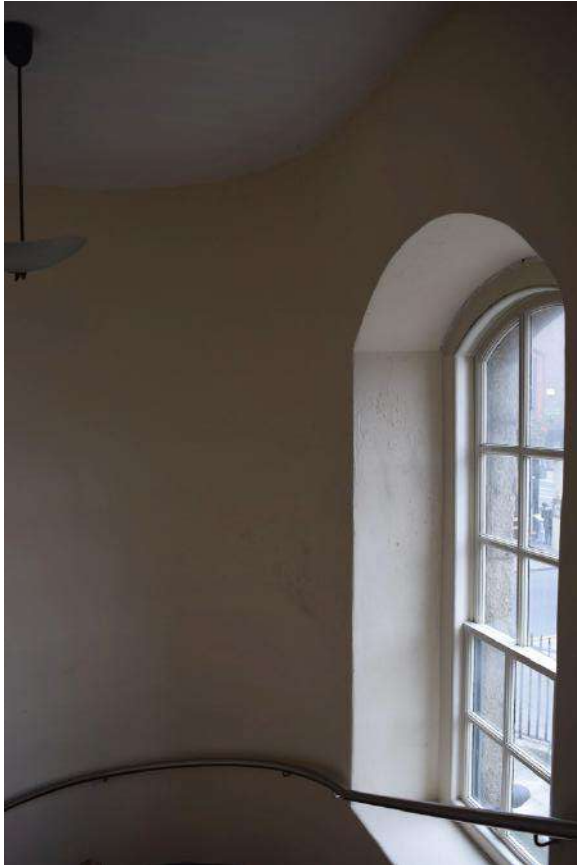
PLATE 39 Damp on wall at landing of stairs

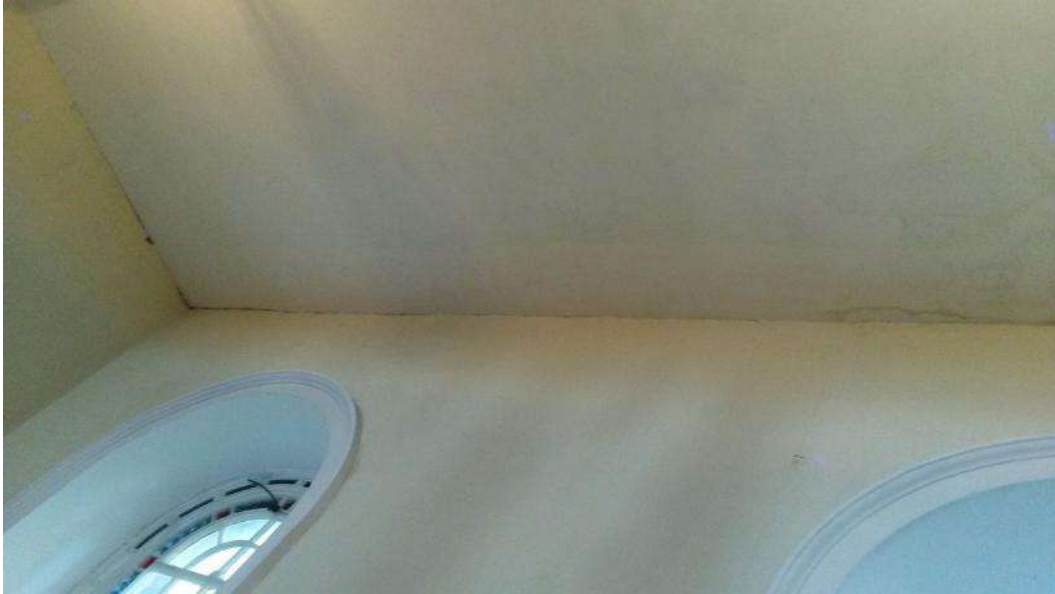
PLATE 40 Damp staining at wall and ceiling junction along southern external wall

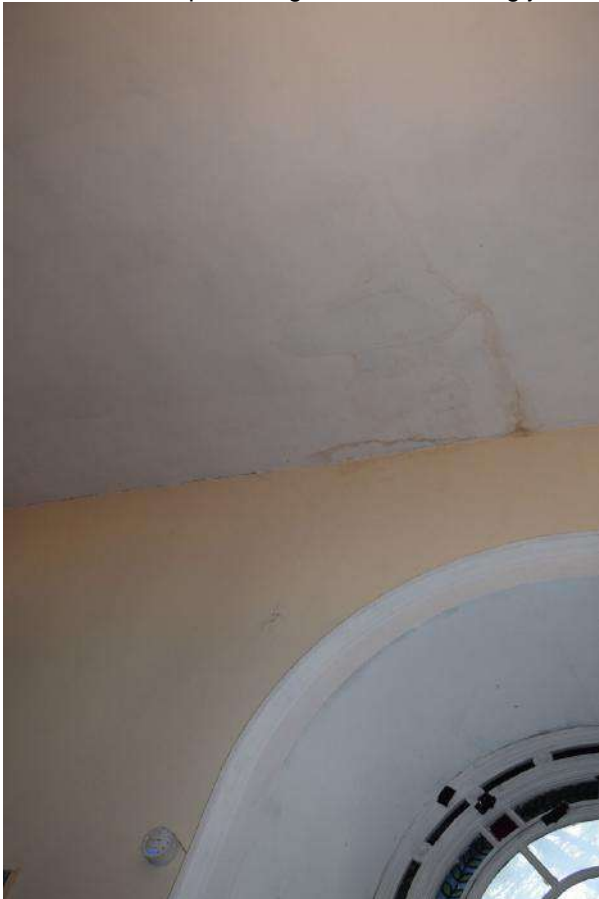
PLATE 41 Damp staining at wall and ceiling junction along southern external wall

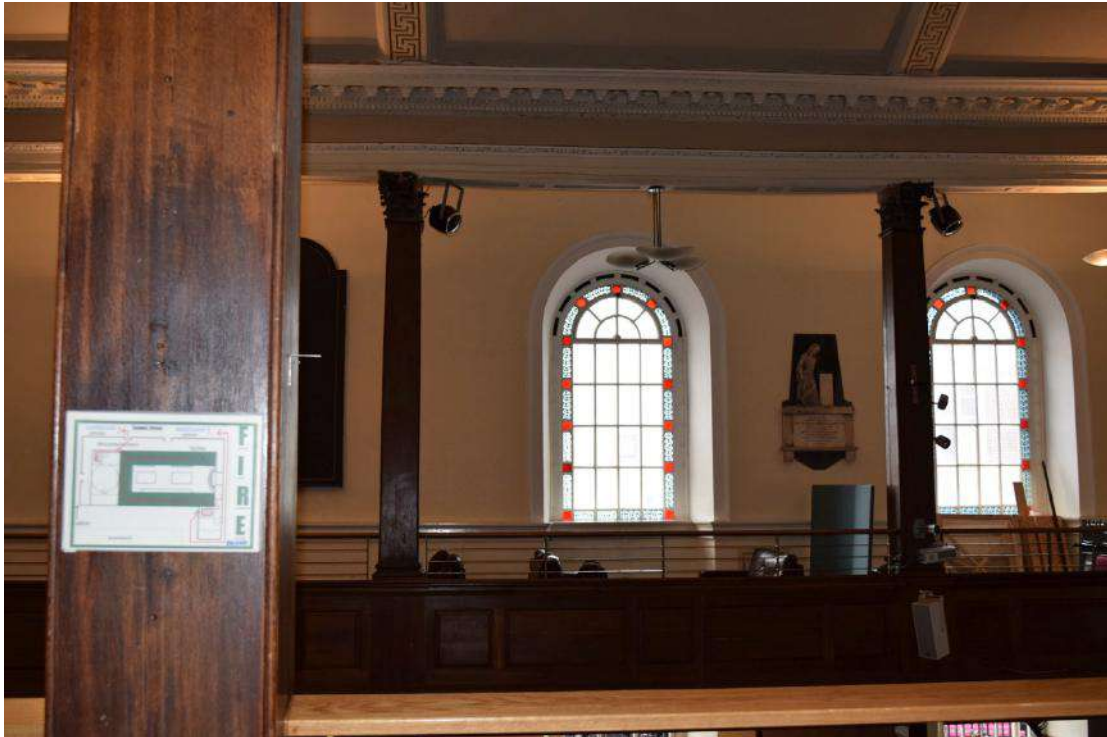
PLATE 42 Bowing of beams between coulms require monitoring

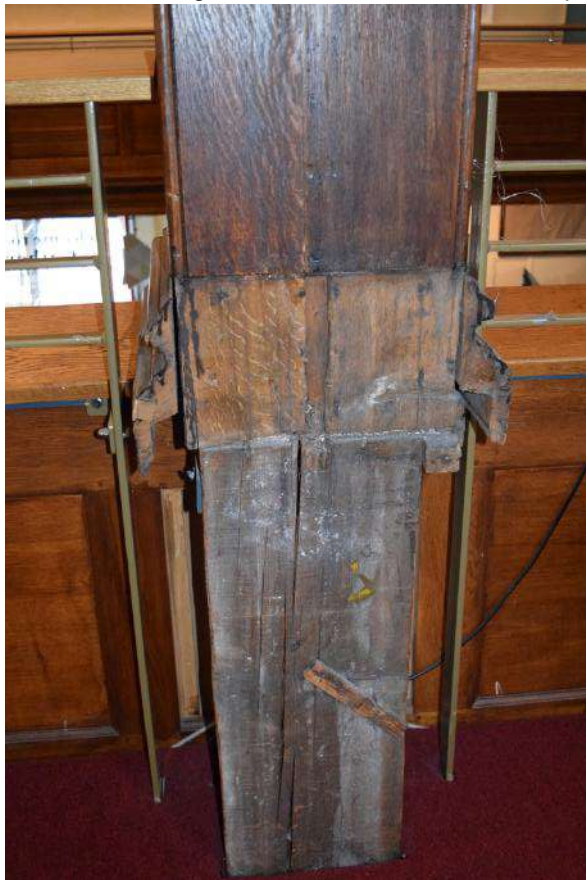
- Add temporary protection to lower levels of first floor gallery columns. The original timber-veneered casing to these columns are broken and splintered posing a risk of injury to passing persons and children using the space. The historic fabric should be retained inside any temporary encasing to facilitate later restoration.

PLATE 43 Damaged timber lining to Timber columns

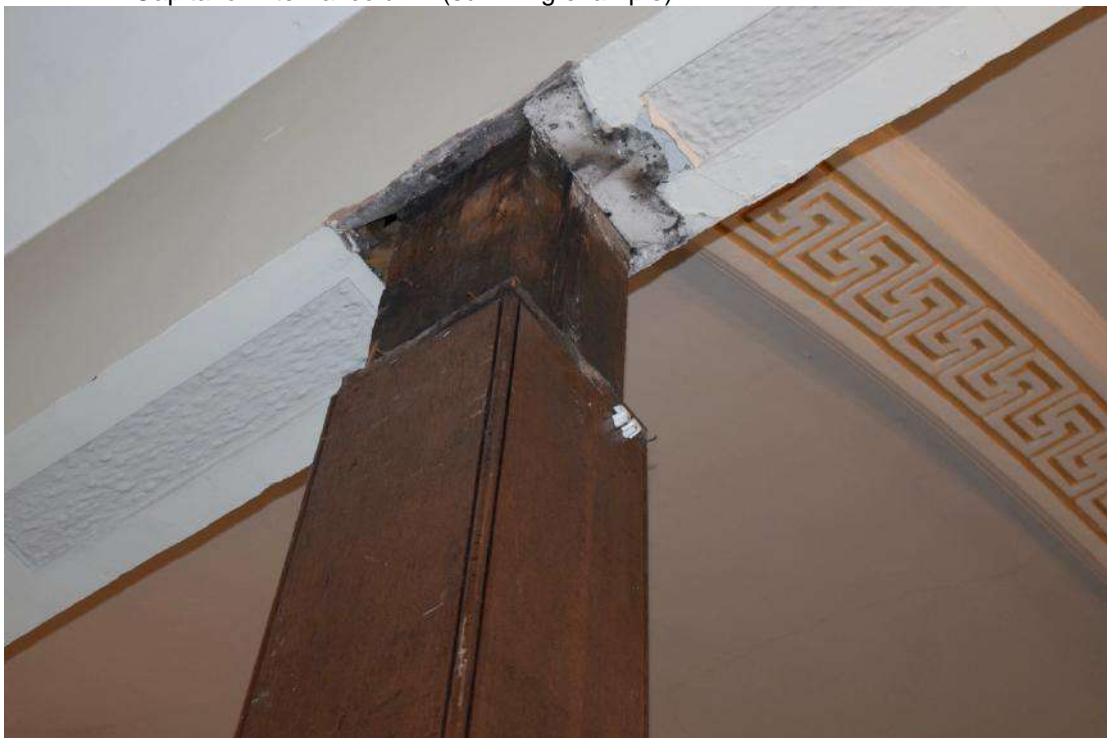
PLATE 45 Damaged/ missing capital of internal column

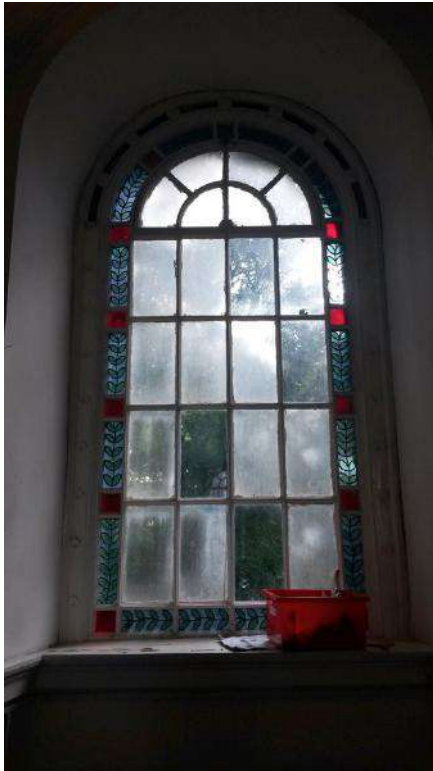
PLATE 46 Typical Upper Level Window to Main Church. Note fogged planes

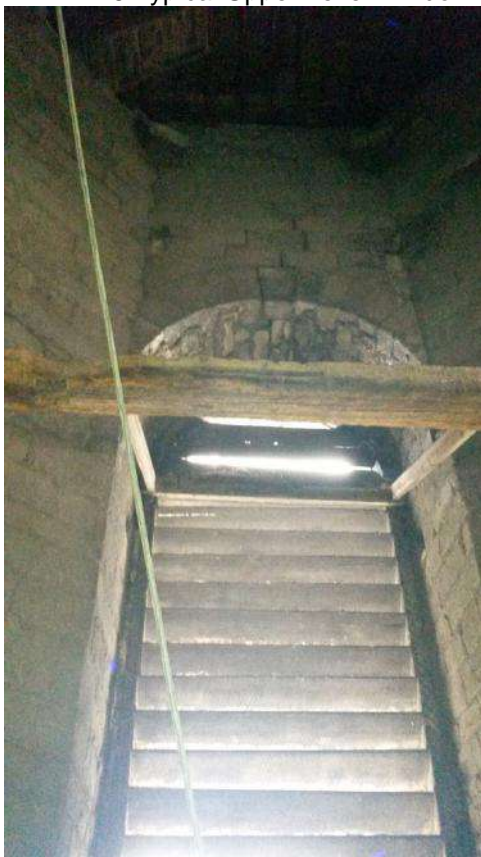
PLATE 47 Slipped Keystone to Arched ope in Belltower

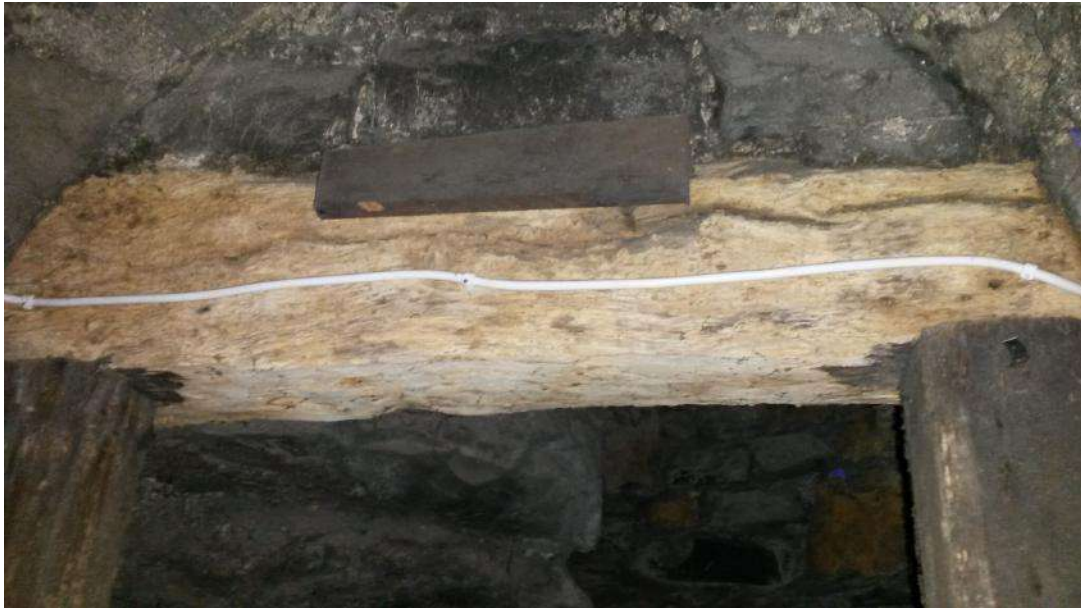
PLATE 48 Beetle infestation to timber lintel in Belltower
